# CLUN TOWN HALL MUSEUM

## Condition Report January 2021

## CLUN TOWN HALL MUSEUM CONDITION REPORT

This report was written by Tim Ratcliffe (Architect), based on an inspection made in January 2021.

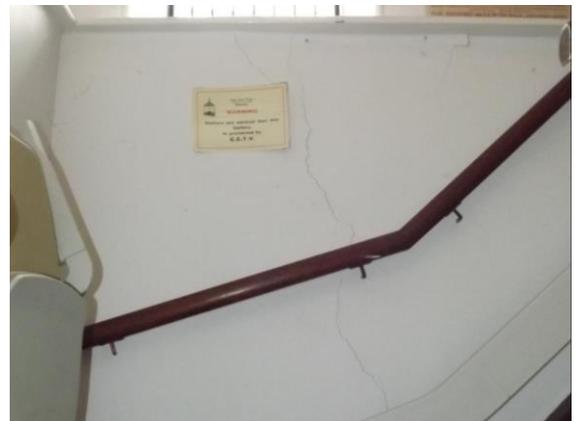
The various cracks in the plaster and abutting joinery in the south and north walls at the west end, suggest slight outward movement of the west and north walls, primarily at the north west (staircase) corner.

The cracks between the skirting and wall at first floor level, close to the fireplace, has been filled in the past, indicating the movement has been on-going for a while. The movement seems to be caused by the fact that the wall is unrestrained at first floor level in this corner because of the stair. It is not an immediate cause for concern, but it would be worth filling the cracks to monitor the extent and speed of any further movement. Discrete tying could be added at first floor level if problems persist.

It is also possible the problem is exacerbated by the loading on the first floor. It would be worth checking with a structural engineer what weight the floor can carry and consider reducing the loading or add strengthening.

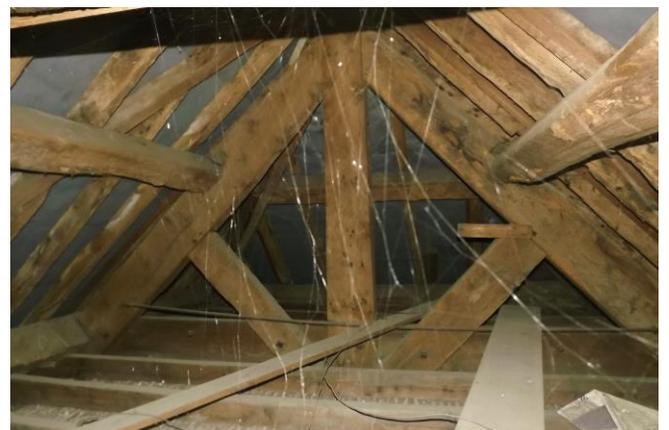
The roof structure is accessed via a hatch in the ceiling. Three substantial king-post trusses support purlins and rafters, all of which appear to be in a sound condition. The lower sections of rafters and the timber wall plates are hidden behind the vaulted ceiling, so could not be inspected, but there are no signs of movement or other problems.

There were some spots of white mould or mildew on the king-post to the middle truss which seem to relate to a leak from the clock turret/cupola above (see next page for notes on the cupola).

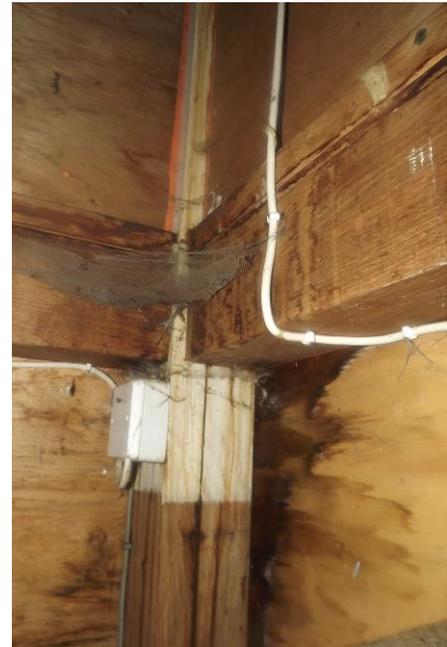
Discolouration on the southeast corner post suggests there may be some seepage here as well, which needs to be investigated and repaired.

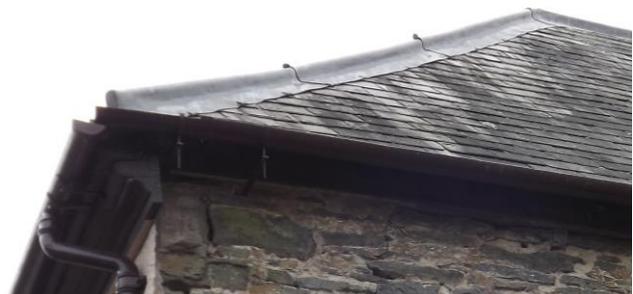
The slates and lead all look to be in a good condition and the only point to note is the lead tabs at joints are lifting, which suggests the lead rolls may have slipped very slightly. It would be worth dressing the tabs down, when there is next access to the roof, to discourage further movement.

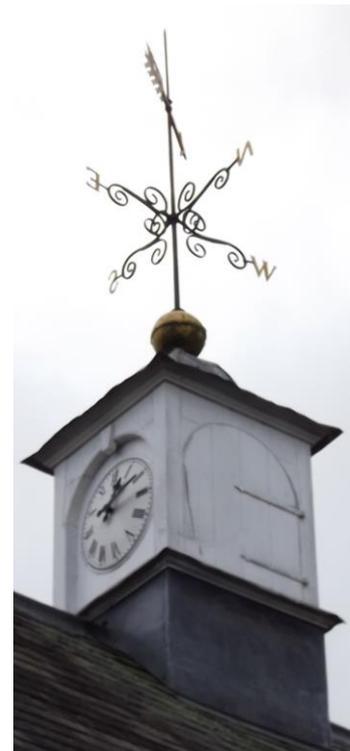
The cupola is capped in lead, with a weathervane above. The ball at the base of the pole is losing its gold coating, and this and the weathervane would benefit from repainting and regilding to prevent further damage.

The sides of the cupola are painted white. There is some black discolouration on the bases of corner posts relating to the leaks noted inside. These need to be accessed and repaired and the panels supporting the clockfaces need repairing and repainting. The panels are plywood, and it is not clear how the lead upstands below them have been detailed. This detail may need to be reformed to give better weather proofing.

The door/hatch in the north (rear) face of the cupola could not be opened at the time of the inspection as it appears to have swelled and jammed. This needs to be released and eased in warmer and drier conditions.

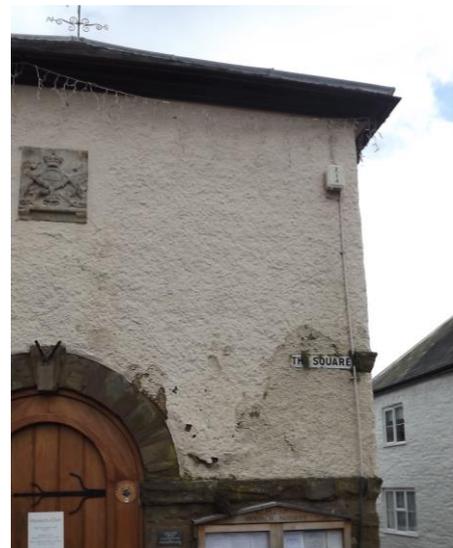
Localised damage to the paint on the render on the west (market square) elevation, and some plant growth, suggest the gutter on this side overflows regularly. It would be worth checking this in heavy rain and also seeing if water spills out elsewhere. The best option may be to install deeper section gutters. Gutters should be accessed and cleared annually.

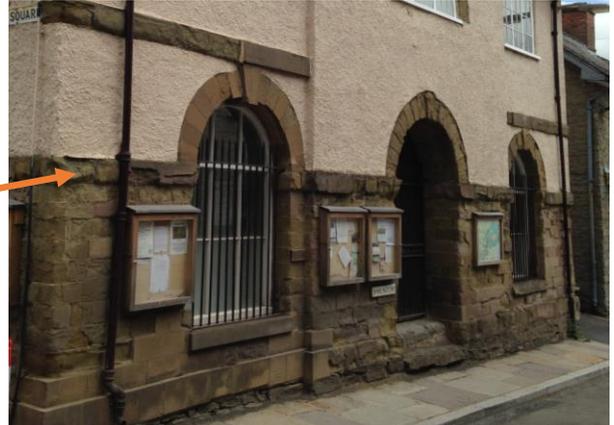
Erosion and delamination of the string course stones is causing more weathering of the ashlar stones below. Replacement of the damaged string course stones is recommended, and localised defrassing & pointing to the stones below.

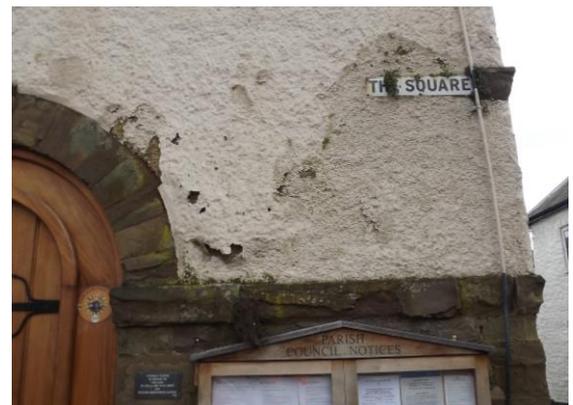
Although the render looks in poor condition, closer inspection indicates a lot of the delamination is the modern paint bubbling and peeling, mainly in areas where the gutter has been leaking. The loose paint, and edges of render that are similarly affected, should be removed, as soon as possible, to prevent water being trapped behind and allow the condition of the render to be properly assessed.

In the slightly longer-term, it would be best to remove the rest of the modern plastic paint (possibly using a Doff steam stripper), repair the render and apply a breathable paint. The extent of render repair can only be assessed after the currently peeling paint layers have been removed.

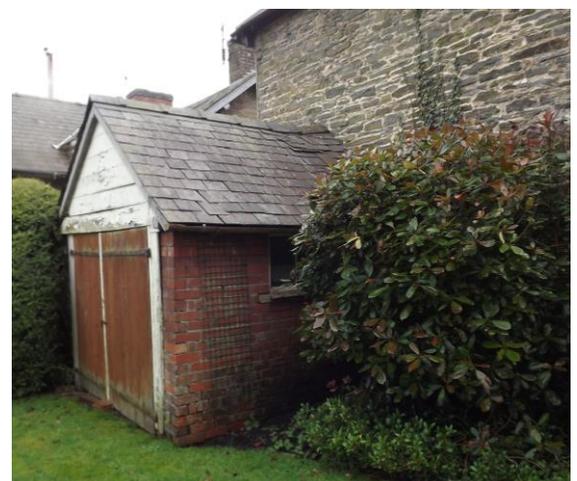
There was a small amount of ivy growth on the rear elevation, which needs to be kept cut back. The shed against this side does not seem to be causing problems, but slates on its roof are beginning to slip. Removal may be visually desirable, if the owner no longer wants to retain it.

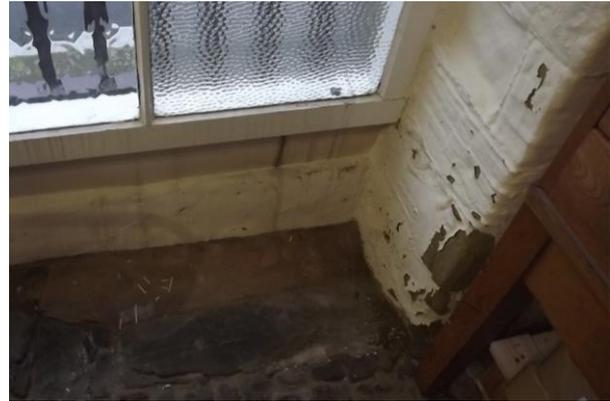
The window frames in the two ground-floor arched openings look relatively modern. Water staining internally, below the frames, and surface erosion of the jambs at low level, indicate leaks under or around the bottom of the windows. This needs to be investigated and the sill detail improved, along with localised repairs to the bases of the frames.

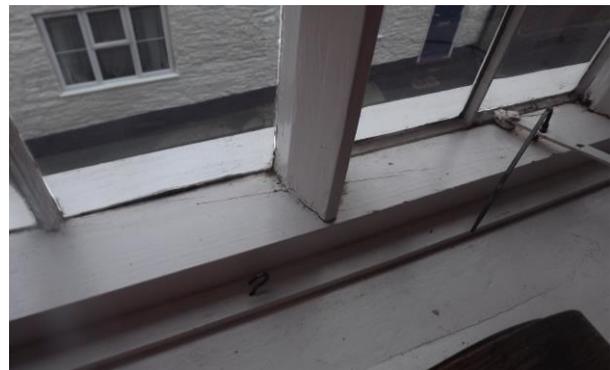
The three first floor windows in the south elevation are all in reasonable condition. Some minor repairs, including filling cracks in sills and replacing small sections of putty, are recommended, plus sanding and repainting.

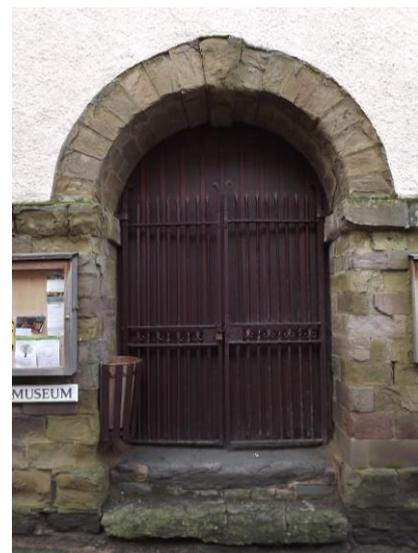
The wrought iron gates in front of this door would benefit from repainting in the foreseeable future. They are currently painted the same colour as the door, so are relatively invisible. Thought should be given to painting them and the timber behind different colours.

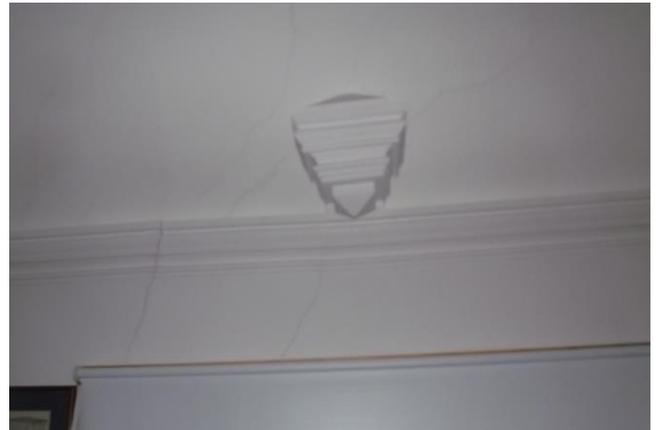
Cracking in the coving and cornice generally seems to relate to structural movement noted in section 2.1. Although not an immediate cause for concern, it would be worth filling these to monitor further movement.

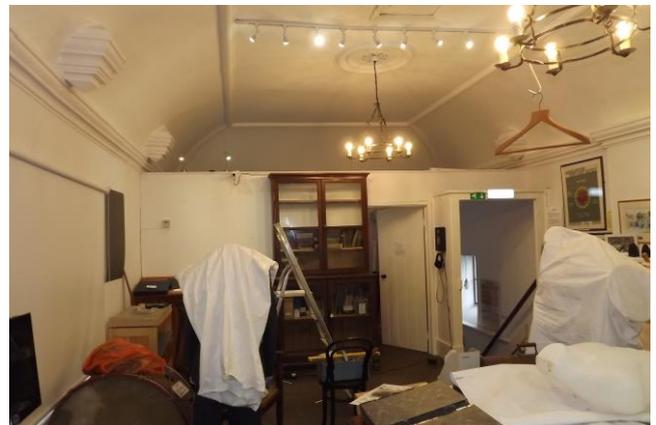
A partition wall at the west end of the first-floor cordons the office and stair from the rest of the space. Although it seems sound, it is not clear how much strengthening was included when it was installed. It may be contributing to the cracking in plaster at this end (along with the weight of stored items), and no further loading should be considered unless a structural engineer advises otherwise.

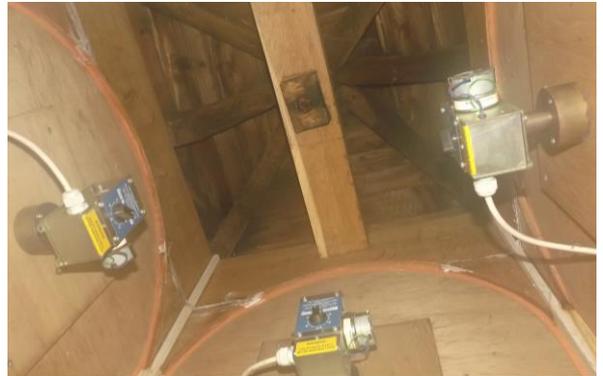
The hands to the three clockfaces on the cupola are turned by electrical clock mechanisms. One of the clocks was not working at the time of the inspection. Since then, all three have been replaced with new ones, by Smiths of Derby.
